Geomorphological processes in the Danube Defile

Case study: The Liubotina slide and the Mraconia collapse

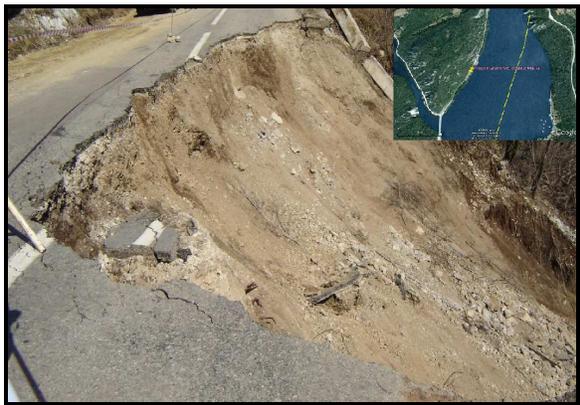
Fig. 2: The collapse of Mraconia

The *Cazanele Mici* slump is (fig.2), chronologically speaking, the first geo-morphologic process discussed. It occurred in early March, on March 9, 2010, and is located circa 300 meters

The distance from the slump rim to the toe of the slope amounts to around 200 meters, which means the landslide involved a huge mass of dislocated material, which impacted on the entire mountainside, blocking and wrecking the national road surface on a 130-meter section. The volume of the rockmass displaced is estimated at 100,000 cubic meters; part of the flow coming down the slope collapsed into the Danube river.

downriver from the Mraconia valley confluence with the Danube; it damaged one section of the DN57 Eşelnița-Dubova national road, as the parapet collapsed, all the way to the median line of the road, on a distance of around 30 meters. The slump is 20-meter high from waterline to the road level; the rebuilt parapet is 8-meter high.

The process occurred inside a lime rockmass which featured vertical faults, alongside several processes which were partially the cause for the onset of the slump, that is a 90-degree declivity, lake water level fluctuations and the improper means used in road construction. A relevant argument in favor of acknowledging and protecting the environment is that on the right-hand bank of the river, in Serbia, the responsible approach to works on the road linking Kladova and Golubac meant no processes similar to those on the left-hand bank of the Danube occurred, although the geological and mineral conditions are similar.

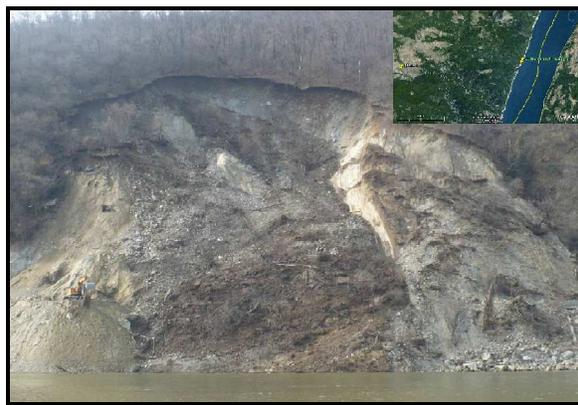
Fig. 3: The landslide of Liubotina

The second recent morphodynamic process considered consists in a *detrusive-type landslide* (fig. 3), slump that occurred late in March, on March 26, 2010. It occurred upstream of the Cazanele Mari, more exactly in the near vicinity of the Liubotina valley; it consisted in a massive and complex landslide on the versant located alongside the DN57 Dubova-Şvinița national road, at an absolute altitude of 155-160 meters.

The morphodynamic process that crested the premises for the emergence and onset of the massive landslide caused a series of micro-forms of relief: the slump ravine, the body of the flow and the toe of the slope.

The *ravine* is semicircular-shaped, with steep, even vertical walls, reaching up to 15 meters in height in the central section; it marks out, in a clear and continuous line, the jagged mass of the flow. The slump funnel is also clearly marked out on its

lateral sides, by means of 5-to-10-meter-high steep slopes, angling downwards.

The *body of the flow* features several microreliefs– jumbled piles, gradations and curves caused by the flow mass molding onto the ragged contour of the bedrock slope. The slope's visible sections have an abraded look, especially on rockfaces and along the alternating bands of clay, as the result of friction between the moving mass of rock and the rock in situ. The mirror-like look is even more obvious when bedrock was dragged along in the landslide. The flow mass consists in a mixture of uprooted trees, detritus and an important amount of weathering crust. A part of the flow mass descended over the national road and into the Danube river, creating a sizeable mass of alluvia.

The *toe of the slope* ended up in the lake water, around 100 meters from the roadside. As a result of the resilience of the body of water as well as the pressure exerted by the flow mass on the move, the toe of the slope shaped up like a breakwater. The contributing factors also included the momentum of

the flow, and the milder slope grade close to the riverbank; the milder slope combined with the thickness of the landslide to preserve the vertical position of the trees dragged along, visible from mid-altitude at the lake's 65-meter absolute altitude.

As in any geomorphologic process, the fundamental causes are: rock, gradient and water. In the situation analyzed, one must point to the thick layer of slope deposits, especially in its lower third, deposits consisted in matter with a high rate of plasticity, as the result of alternating bands of clay. These deposits lie on top of serpentine soil, magnesian slate, with a high content of chlorite, talc and chrysotile, in various stages of weathering. The alternating bands of clay combined with the steep gradient – an average 45-degree angle – and the existing faults and crevices easing infiltration and excessive water accumulation to create the premises for the process trigger.

Work is now being done to consolidate the mountainside at the road level, but the existence of crevices in the higher reaches makes it likely to ease further landslides, in the long run, as the respective

location remains an active one. Work to consolidate the mountain slope in the area of a previous landslide in the vicinity also contributed to destabilizing the mountainside.

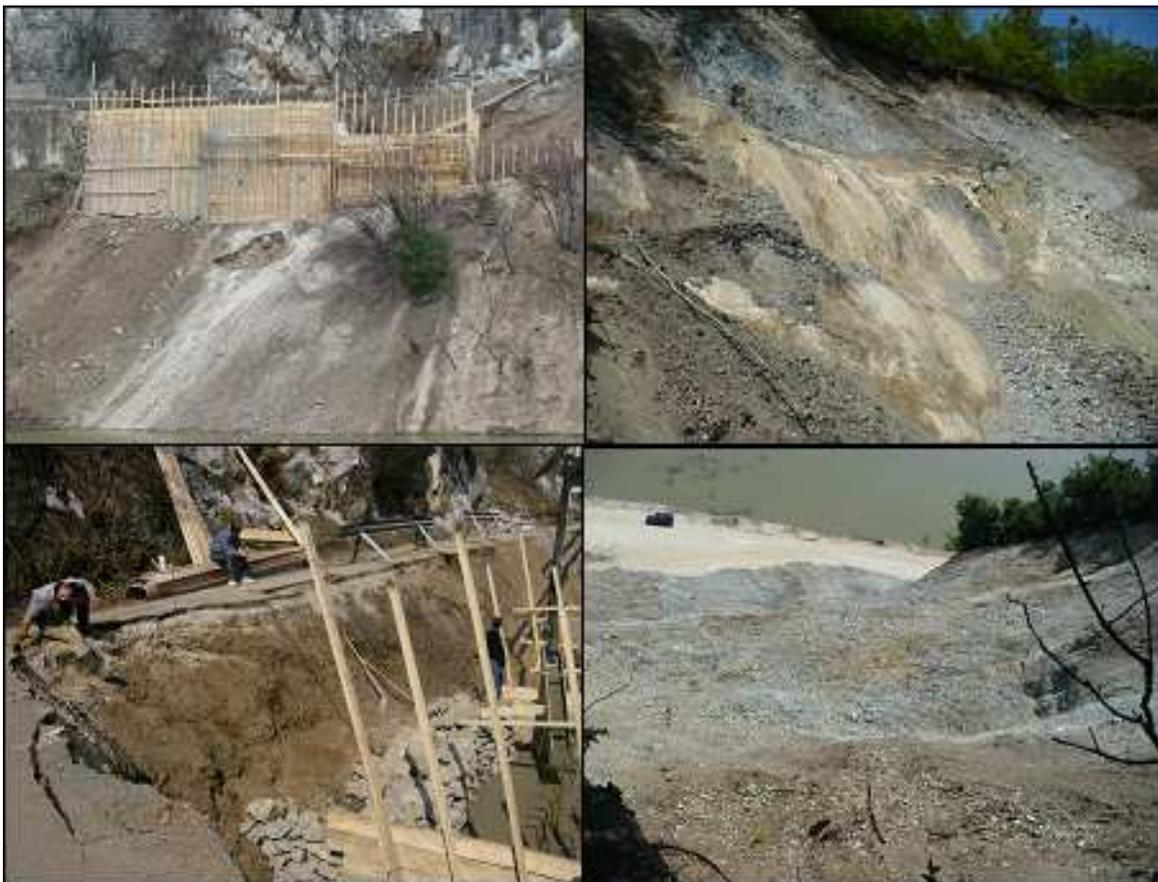
Fig. 4: The collapse of Mraconia and the landslide of Liubotina

The very important role played by human activities, both direct and indirect, has to be acknowledged: the direct cause was interference with the natural balance of the gradient, when building the road linking Orşova and Moldova Nouă. The manner the road was built was just as harmful, as it involved blasting the mountainside and shoveling the excavated material into the lake water. The blasts caused new crevices in the mountainside mass and enlarged the existing ones. Indirectly, the 5-meter-plus fluctuation of the lake waterline, undermined the cohesion of the underlying mountainside by means of alternating moistening

and air exposure; road traffic is also one of the preliminary causes, in terms of the vibration it causes.
