# Aspects regarding the evolution of slope processes in the Izvoru Alb – Bicz territory (Neamț County) during 2005 – 2014

**Keywords:** natural dam lake, effects on settlements, present state of landslides

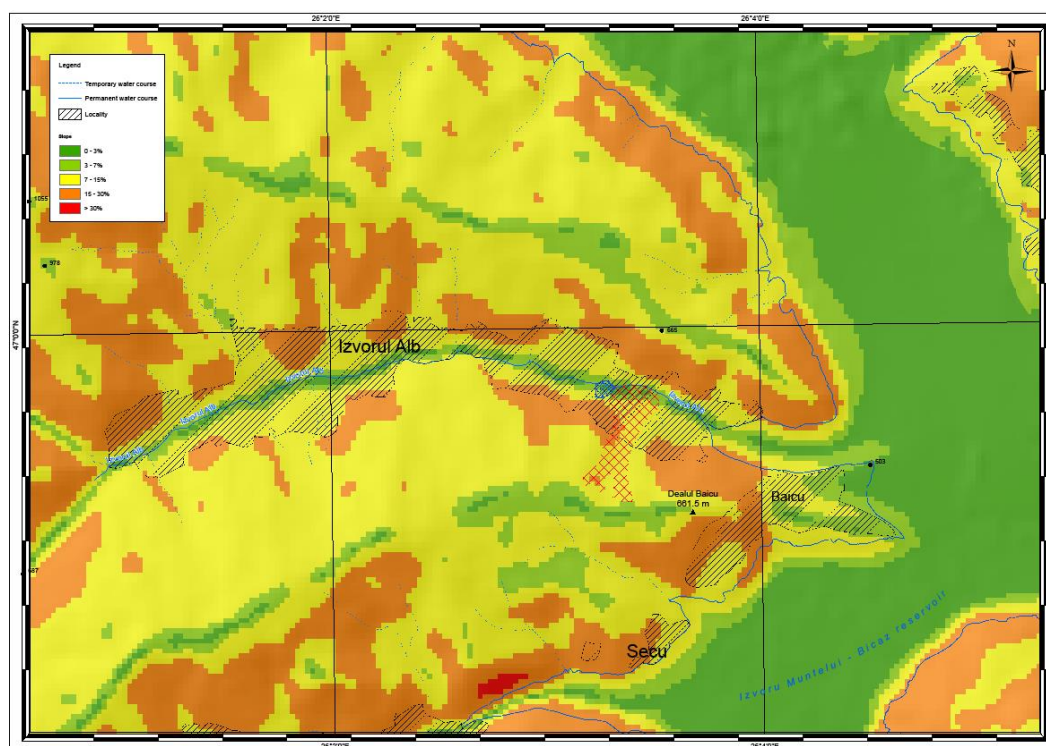
Fig. 2 Slope angle map

flysch (Izvoru Alb brook reaches in the spring area the base of the Ceahlău conglomerates). Considering the influence of morphometry, important are the relative relief, with mean values of 300 m on the territory of the village, and the high slope angle, with mean values of 7-15% and 15-

30% (Fig. 2). The mean annual rainfall exceeds 900 mm in the rainy years, while absolute maximum rainfall quantities can reach in the warm period of the year values that can sum up to 100-150 mm in 3-4 days (Fig. 3).

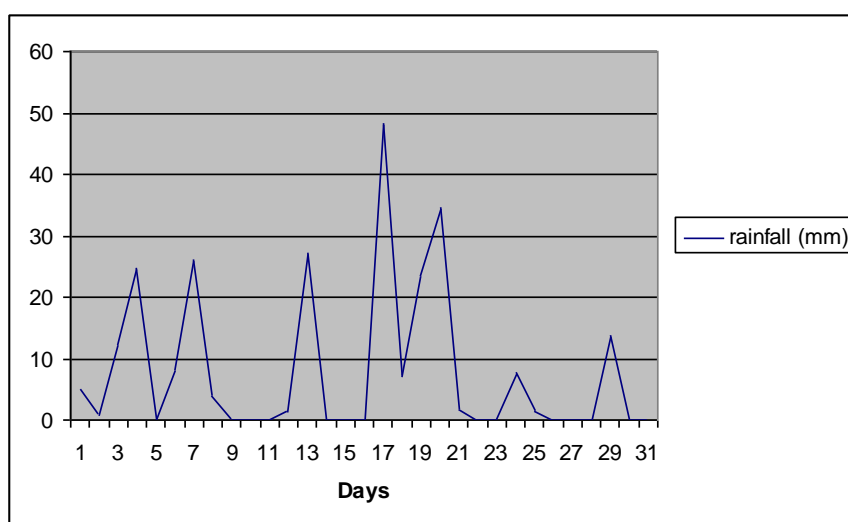
Fig. 3 Rainfall quantities recorded during August 1<sup>st</sup> -31<sup>st</sup> at Izvoru Alb

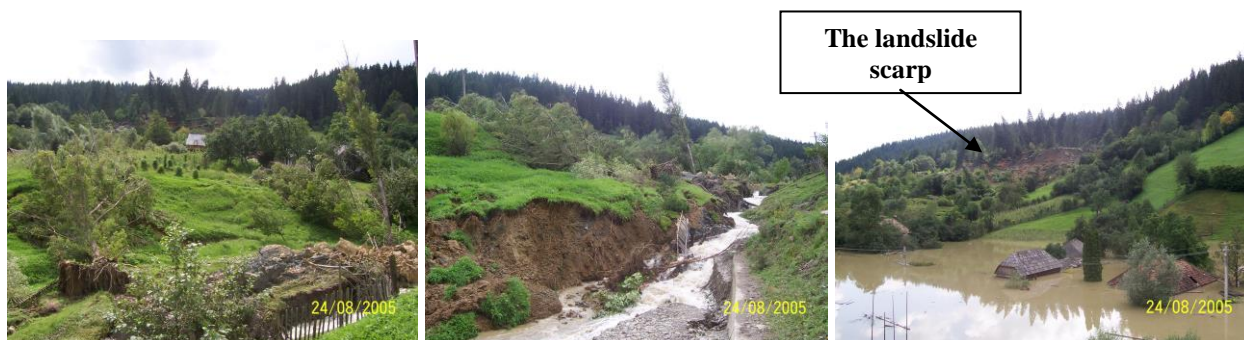
Fig. 4. The landslide that formed the natural lake in Izvoru Alb, August 2005

Among the main geomorphologic processes that have taken place during 2005 and 2006, on August 16<sup>th</sup>-22<sup>nd</sup> 2005 have been registered abundant rainfall, when in the Izvoru Alb brook has been recorded a summed quantity of 125 mm. This led to a deepening of the brook's channel, followed by bank erosion on the right side with a level difference of 1 – 3 – 5 m (in different sectors of the floodplain). In the night of August 22<sup>nd</sup> at 2-3 PM (according to the information given by local people), a debris flow of large dimensions (length of 350-500 m, width of 100–150 m and a thickness of the landslide mass of 3–5–8 m) detached from a scarp situated in the upper third of the slope and suddenly collapsed, reaching with its forehead the brook floodplain. Blocking the floodplain, it determined the formation of a lake (in a period of 72 hours according to the locals), with an estimated surface of 2.5 ha, a mean depth of 2–3 m and maximum of 8 meters, and flooded households, agricultural terrains and roads (Fig. 4). According to the information from the inhabitants, in 2006 have taken place landslide reactivations locally, on small areas, as well as some material losses.

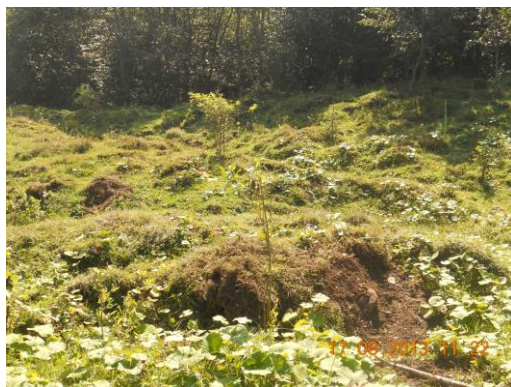
Fig. 5a. Hygrophilous vegetation on the right bank of Izvoru Alb brook, August 2013

been noted mass, which blocked the floodplain in 2005 causing the formation of the lake. By repeated measurements of some landmarks it was concluded that on the overall the main debris mass does not register movements. Yet, on areas of different dimensions situated in its vicinity have occurred new small depressions with temporary humidity excess and even ponds (hygrophilous and swamp vegetation), as well as micro-landforms such as furrows, small secondary scarps, cracks and bumps which are proof of small local horizontal and vertical movements (Figs. 5 a and b);

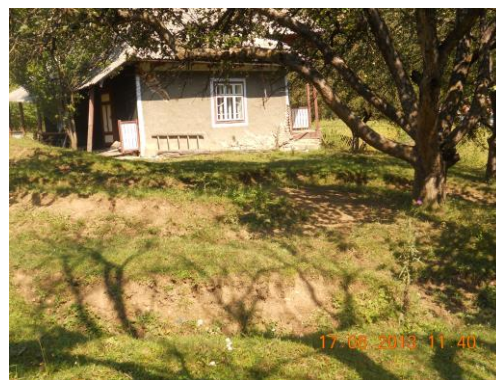
Fig. 5b. Secondary scarps in the debris mass, August 2013

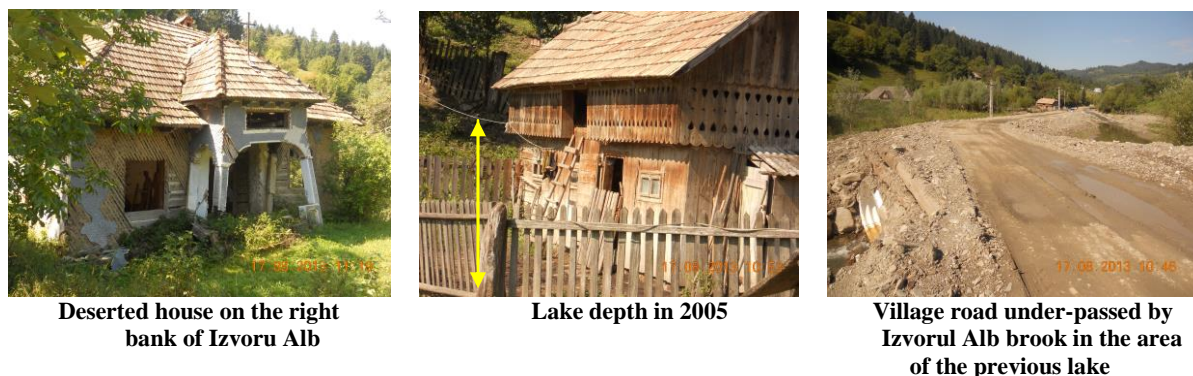
Fig. 7. Present situation of the study area / affected buildings (August 2013)

- Regarding the evolution of the lake and of its surface, we need to point out the total evacuation of the lake water (except some small ponds and areas with swamp vegetation) as a consequence of the locals digging an evacuation channel in the debris mass. The 2.5 ha previously occupied by the lake has been eliminated from any utilization. Also, most of the previous households and terrains are in the same situation (Fig. 7);

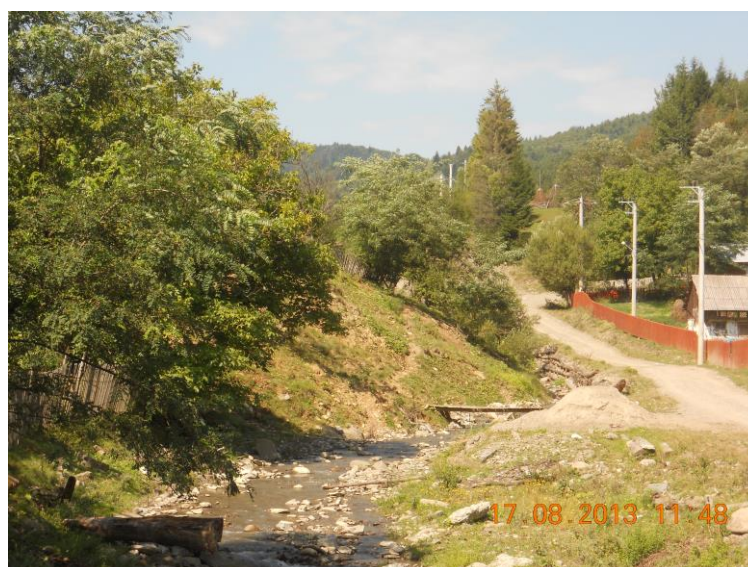
Fig. 8. Inhabited households on the left bank of Izvoru Alb brook, August 2013

- Regarding the negative social and economical effects, it is important to mention the deserting by locals of 13 households in 2005 and another 4 in 2006, due to their flooding or damage by the landslides. Here are also included the inhabited

space, the terrains around the households used for crop growing, electrical network, fountains etc. Thus, Izvoru Alb, mentioned for the first time in 1458 in a document issued by Ștefan cel Mare as a group of houses situated at the confluence of Izvoru Alb with Bistrița, and then on the maps of Cantemir in 1717 and Bauer in 1772, is presently registered at the Bicaz mayor (of which it depends) with 129 households and an ageing population in a constant decline. According to some information from the locals, only 70 families are now permanently living in the village (Fig. 8).
